Inspection of Churches Measure 1955 & Care of Churches Ecclesiastical Jurisdiction Measure 1991		
<b>DIOCESE OF ST ALBANS</b>		
DIOCESAN SCHEME FOR THE INSPECTION OF CHURCHES (The Quinquennial Inspection)		
<b>Church of St. Lawrence</b>

Location of the church:	Church Street Bovingdon SG13 8AY	
Local Authority:	Dacorum	
Listing: Church	Grade II*	
Inspecting Architect:	Francesca Weal MA DipArch (Cantab) RIBA SCA	
Address:	2 Mill Walk, Wheathamstead, Herts AL4 8DT	
Contacts:	01582 832907 : francesca@weal-architects.co.uk	
Dates of inspections:	10th July 2018	
Weather:	Sunny and warm	
Date of this report	5th September 2018

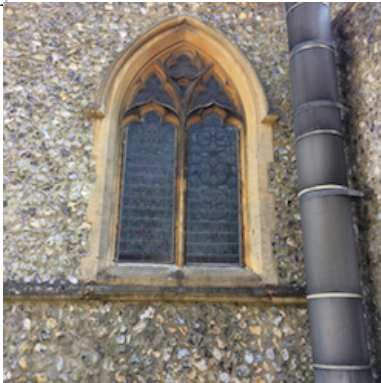
<b>4.01</b>	<b>North Elevation</b>		
	Comprises upper section of nave with 5 clerestorey windows with square hood moulds. Lower level buttressed single -storey north aisle with 5 windows with arched hood moulds. Single storey former vestry (now kitchen) to the NE of the north aisle with small WC extension. Chancel elevation with single window with arched hood mould. Generally sound but with areas that need attention. Walls are flint with stone detailing. Some of the stone is chalkstone (known as 'clunch').		
<b>4.1.1</b>	Chancel - no significant issues. Photo shows WN1 and also the flue from the heating chamber below. Rust staining from window guards evident. <i>See later section on windows for action.</i>

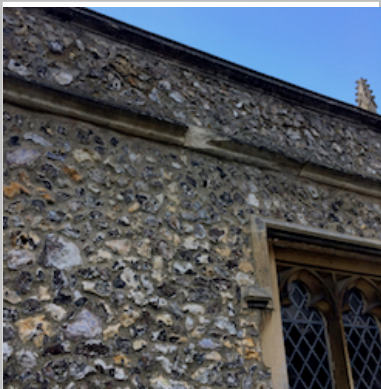
4.1.2	Significant spalling to the quoins and cement pointing to NE return to former vestry (from henceforth referred to its current use as the kitchen) . <i>Photo &amp; action</i> in later section.		
4.1.3	Open joint in coping to nave roof near WUN3. <i>Check bedding of coping and point.</i>		2
4.1.4	Spalling to string course to lhs(left hand side) of WUN3 and open joint to parapet coping over WUN3. <i>Repair to prevent further deterioration.</i>

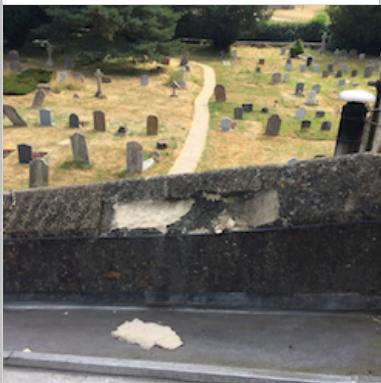
4.1.9	Spalling inside of parapet to NE end of north aisle. Also spalled top of coping further down the slope (not shown on photograph). This is quite a severe deterioration and was not evident in 2013 . <i>Assess parapet and repair.</i>

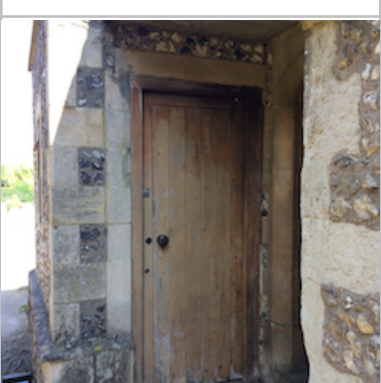
2
4.1.12	Stone surround to DE1 (external door into the WC) spalling on left hand side. <i>Repair depending on outcome of proposed works.</i>

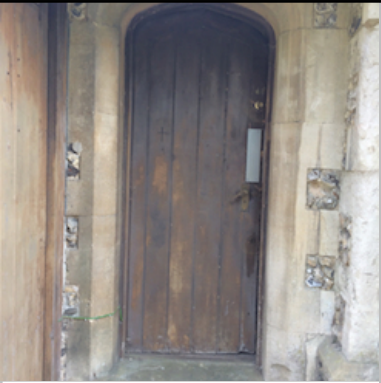
4.1.13	Stone surround to DE2 (external door into the kitchen) Generally satisfactory - one stone on the right side is split and there is some loss of stone at low level. <i>Repair depending on outcome of proposed works.</i>

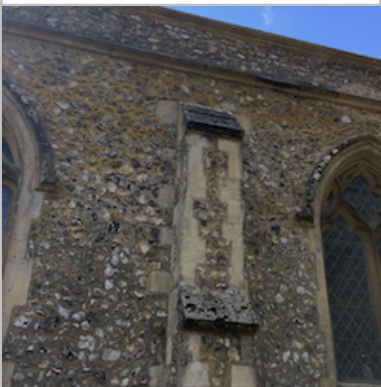
4.1.14	Open joints in walling above and to the sides of B17 and B16. Photo shows B16. The flints appear to have been pointed in with cement mortar which is not at ideal. <i>Point joints to prevent damp ingress.</i>

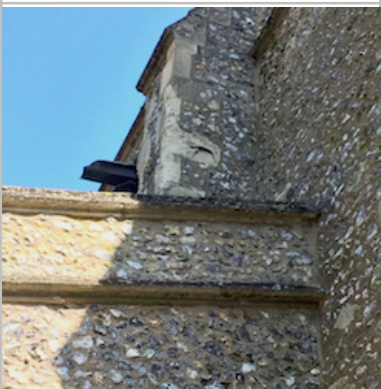
4.2.1	Chalkstone quoins to return of B12 are spalling. Otherwise no other significant issues. <i>The quoin stones need attention before more serious loss of materiel occurs.</i>

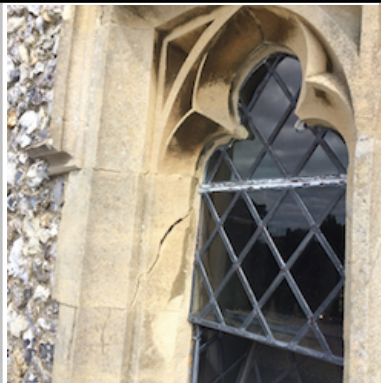
4.3.3	Crack through stone surround to WUS3. <i>Repair.</i>

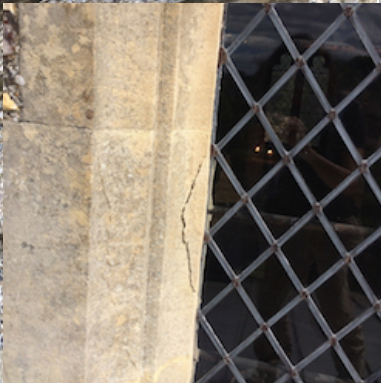
2
4.3.5	Cracks developing in WUS5 and also damaged moulding to hood mould over. <i>Repair.</i>

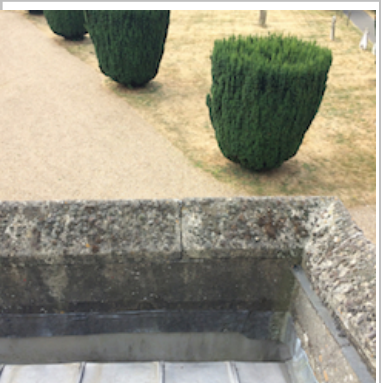
2
4.3.6	Pointing missing to parapet copings in areas. Cracks developing in cement render - photo of SW return corner. And as seen from the ground (bottom right) and on the SE return corner ( below). There are other areas not shown here. <i>Repair.</i>

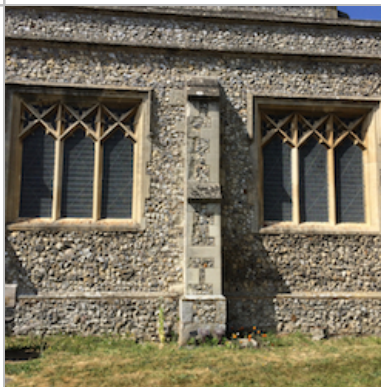
2
4.3.7	Some loss of face from the chalkstone link stones where the porch meets the wall of the south aisle. <i>Repair.</i>			3
4.3.8	Generally the south elevation of the south aisle appears satisfactory. There is some loss of materiel to the quoins to the buttresses but not enough to cause any major concern. However, if there is a programme of stone repairs elsewhere, <i>it would be wise to include some consolidation of the chalkstone where needed.</i>

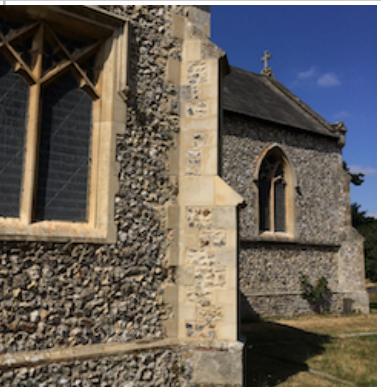
3
4.3.9	Buttress B3 has been recently repaired under the auspices of the previous inspecting architect and is in good condition.

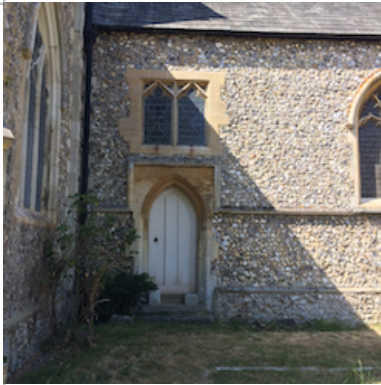
4.3.10	The south elevation of the chancel is satisfactory. There is some developing loss of surface to a detail on the hood mould to DS1 ( <i>repair</i> ) and an emerging sapling growing in the return corner to the East elevation ( <i>which should be removed</i> ).

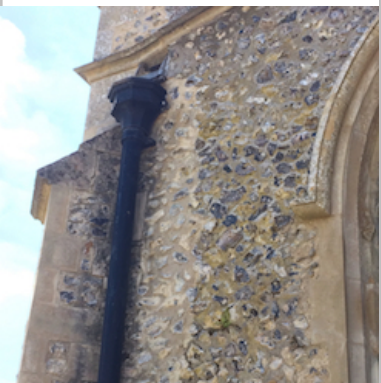
4
4.4.2	Buttress B3 has been repaired (east face shown on photo).

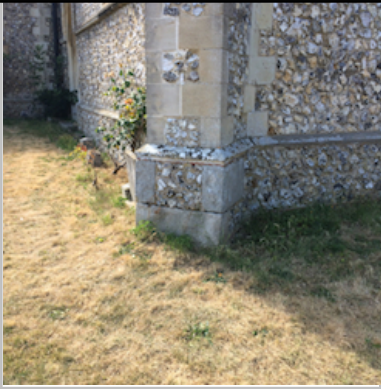
4.4.3	The base of buttress B2 has a joint with missing mortar which should be repointed.

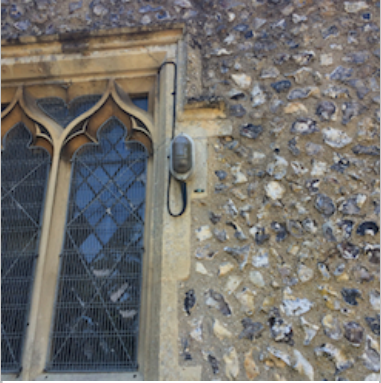
2
4.4.4	There are some defects to the surround & hood mould of WE1. Repair.

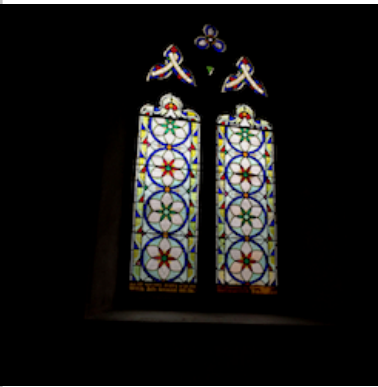
5.1	WN1: to chancel. Previous QIR recommended releading the west light but on this inspection I was not able to discern this. Dated 1857. Rust staining to stonework around fixings to galvanised guards. Rectify cause of staining. <i>Get window assessed by specialist.</i>

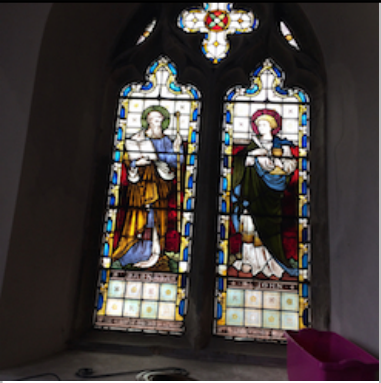
5.18	WW3: west end of south aisle. 2-light stained-glass window of SS Barnabas & John. Clayton Bell 1874. Hole noticed in St John's green robe. Galvanised guards are satisfactory. <i>Investigate if hole can be simply repaired.</i>

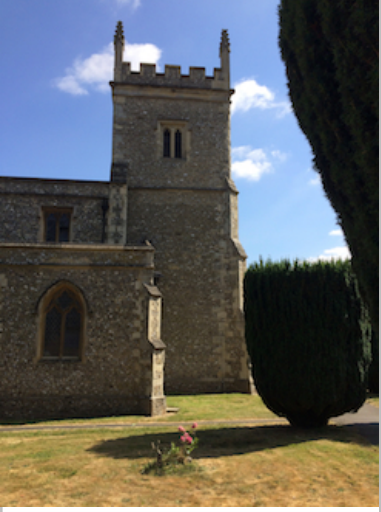
6.1	<b>Tower external walls</b>		
6.1.1	<p>Tower north external face. Comprises semi-coursed flint with occasional puddingstones with what appears to be heavy use of cement-based pointing. Buttress B12 has spalling quoins (see earlier section) and the NW chalkstone quoins of the tower at the upper level are also losing material. <i>Ideally the erosion of the quoins should be reviewed and slowed.</i></p>

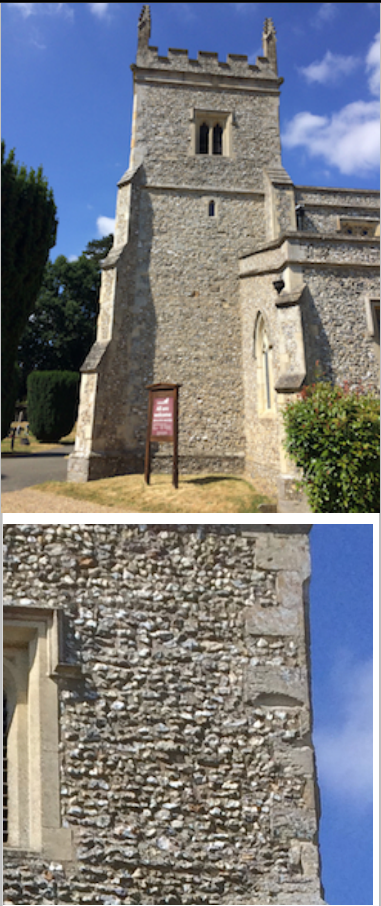
6.1.3	<p>Tower south external face. Construction as described before. Some of the return chalkstone quoins against buttress B10 are losing face. Surrounding pointing is cement based. There are some indentations around the left of the centre of the wall lining just above the halfway point of the second stage of buttress B10. These would appear to be where puddingstones have been used. Previously-reported erosion gash in the quoin 6 stones above the top of B9 is patent. I have no metric to see if it has got worse since the last QIR. Zoom-in of top photo for record purposes.</p> <p><i>If there is a programme of stone repairs elsewhere, it would be worth incorporating work to the tower chalkstone quoins.</i></p>

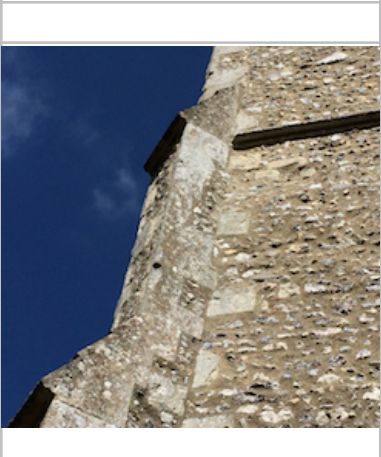
6.1.4	<p>Tower west external face. General image at start of this section. Approximately coursed, unknapped flint with hard cement-based pointing. Some erosion on the SW corners of B10 particularly on the second stage - there have been some new inserts here. Also erosion on the NW corner (previously noted) and a stone in the west quoin of the upper stage of B11 is missing some stone. The stonework to the bell-chamber west opening and the quatrefoil window (not numbered) appears satisfactory. <i>Consolidation to quoins desirable.</i></p>

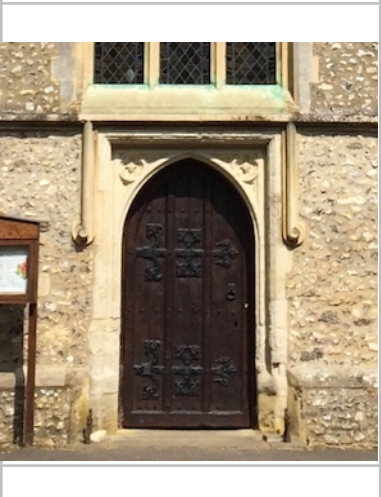
6.1.5	<p>Opening to Doorway DW1. Square-headed doorway some loss of detail to the mouldings and generally detail of the chalkstone has eroded but at present appears in stable condition. Note the previous QIR had recommended dressing-off friable eroded stone which may have been carried out and at some point lime-watering had been used.</p>

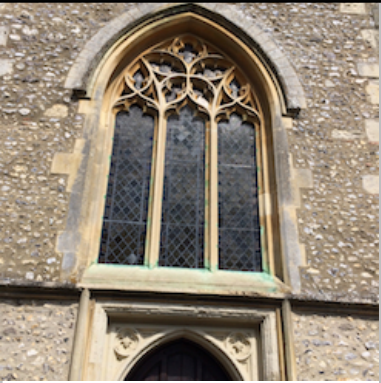
6.1.6	Stone surround to WW2. 3 light window with reticulated tracery ( <i>a style of decorated tracery characterised by circular shapes drawn at top and bottom into ogees, resulting in a netlike framework</i> ). Generally satisfactory - though the stone is being stained with copper wash-off, possibly from fixings of the guards (see earlier comment). A small loss of a corner for a surround stone on the left hand side under the area of reticulated tracery.

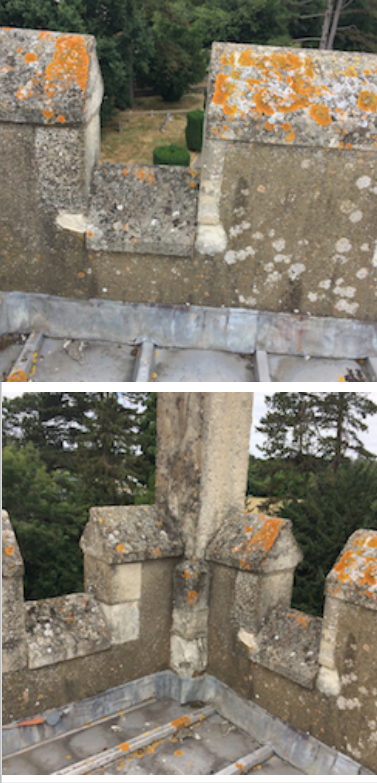
6.1.7	<b>Tower parapets</b>

3 & 4
	<p>None appeared to be unstable when pushed. Noted that the crocketed pinnacles are truncated - having lost some stonework and one is more than the others. Some spalling of the chalkstone at the base of some embrasures and at the base of the NW pinnacle. Cementitious render to the rear of the parapet is relatively impervious and holds damp against the stone making it vulnerable to frost damage. Minor cracks in some areas to the render. <i>Point minor cracks but long term assess redoing the render in a non-cementitious render</i></p>		
	<b>Tower: roof structure, coverings and flashings</b>

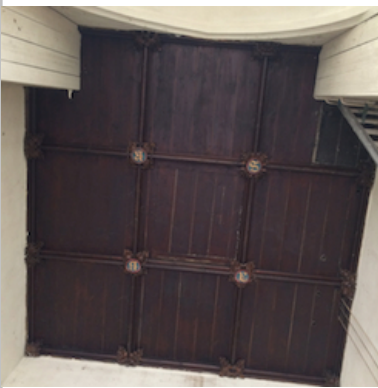
6.2.2	<b>Tower: ground level</b>		
	Fairly level threshold in from the west door. Divided from the nave by a timber screen (see later comments). Flagged floor with a step up to the nave Plastered walls. Corner boxes for the redundant clock weights(according to last QIR) in the west corners. No apparent structural defect but decorations need attention. The ceiling to the clock chamber over appears satisfactory and there are hatches for lowering the bells and a rather unsatisfactory access hatch at the top of the ladder. More comments later in QIR.

<i>Renew contrast strip to step</i>		2
	<i>Tower walls to be redecorated following works to the ladder.</i>		3

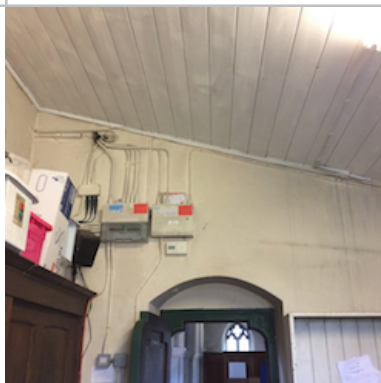
8.3.2	Kitchen: internal		
	Gloss painted boarding, condition of structure behind not known. Streaking noticed on the walls which might reflect the condition of the roof before the re-covering but may also indicate a current problem if the flashings are inadequate. <i>Survey when rot works are done.</i>

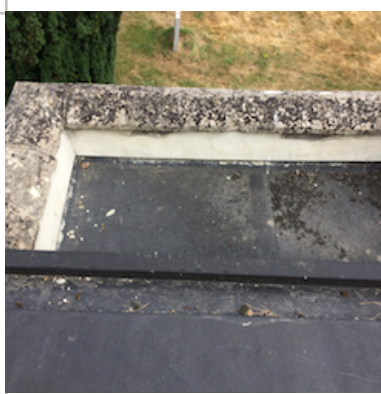
8.3.3	WC Roof		
	Short section of flat roof with parapet surround. Felt roof. Dressed up behind cement render. Some cracking in the render but at present not serious. DPC under parapet stones is partly visible.

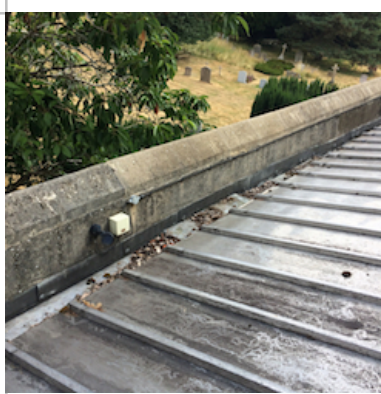
8.4	North Aisle Roof		
8.4.1	External: Mono pitched roof with capped stainless steel sheeting. Have been advised that this dates from 1980. Pitches towards north parapet gutter. Lead flashing working loose (see earlier photo) in some areas. Sheet metal (not lead) cover flashing fixed up part of the raking east parapet. Previously noted at being loose. Roof otherwise appears satisfactory for its age. See other sections for work to parapets etc. <i>Refix lead flashings following completion of parapet work.</i>

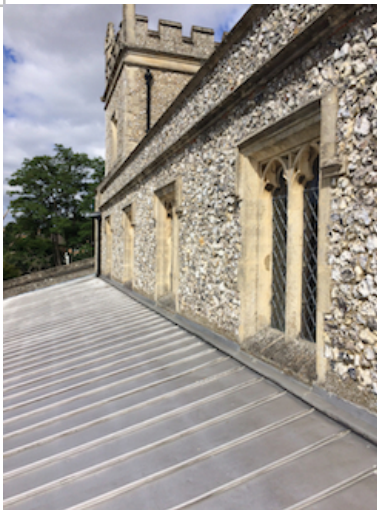
<b>8.5</b>	<b>South Aisle Roof</b>		
8.5.1	<p>External: Mono pitched roof with raised seam stainless steel sheeting. Have been advised that this dates from 1981. Pitches towards south parapet gutter with lead cover flashings.</p> <p>No apparent defect in covering but clearly there has been an issue at the junction of the upstand and the cill of one of the clerestory windows. The seal between the two appears cracked and overcoated. <i>Repair seal.</i></p>

8.5.2	<i>Check and fix back lead flashings to parapet after other works.</i>		2
8.5.3	<p>Internal: Exposed stained chamfer-stopped sw rafters with stained sw boarding over. No apparent defect.</p>

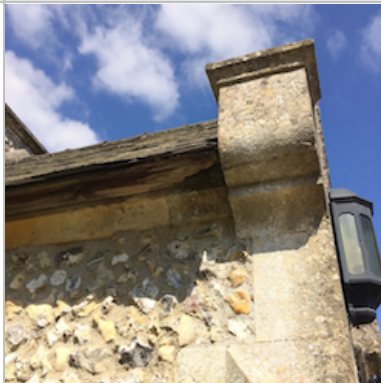
8.3.3	Timber fillet decayed at junction with the parapet. <i>This should be repaired.</i> The east side is also somewhat decayed. <i>Weathering at this junction to be reviewed and rectified.</i>

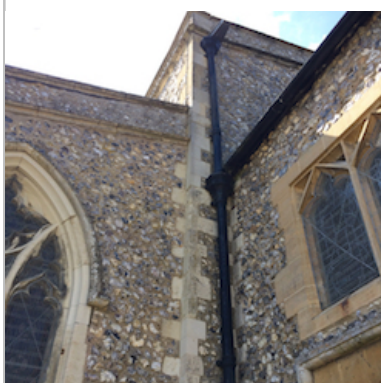
10.0	<b>Rainwater, gutters, downpipes and surface water drainage systems</b>		
10.1	The church has its main rainwater system in the form of parapet gutters which discharge into hopper-headed downpipes via what appear to be recently-made lead chutes and gargoyles. The chancel & kitchen have cast iron gutters. There are no gutters to the south porch. Most of the cast iron downpipes need repainting. Previous QIR drew attention to the junction of the western end of the chancel's south gutter and the downpipe (shown right) and recommended checking during heavy rainfall.

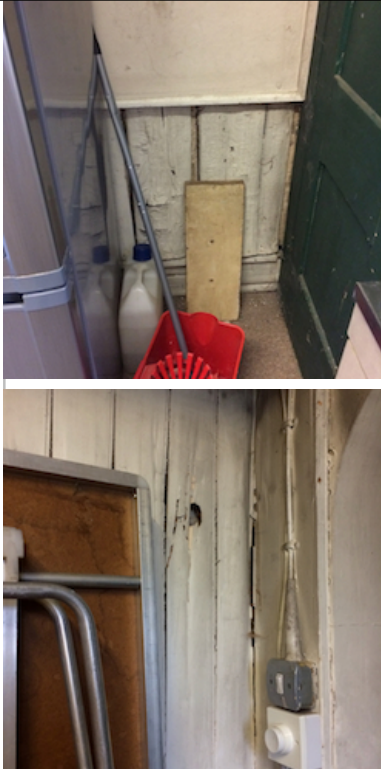
11.2	<p>The kitchen walls are lined with tongued &amp; grooved boarding and the boarding and adjacent trims etc are showing signs of rot in the form of cuboidal cracking. This is manifest on the north wall and around to the wall next the north aisle. Units &amp; cupboards etc preclude examination of the east wall and south walls . This was not logged in the last QIR which was done in great detail, so the assumption has to be that it has developed as a result of the very damp walls drying out following the subsequent roof works. <i>Urgent action is needed to identify the rot (suspected dry rot) and remove infected timber before planning further remedial measures.</i> Note that the usual response from standard timber treatment companies is not suitable for historic construction whether listed or not.</p>

11.7	Kitchen walls are in a very poor decorative state. Previous QIR recommended waiting until the roof works were done and the walls dried out. <i>The issue with the rot will need to be dealt with before any redecoration takes place</i>		2

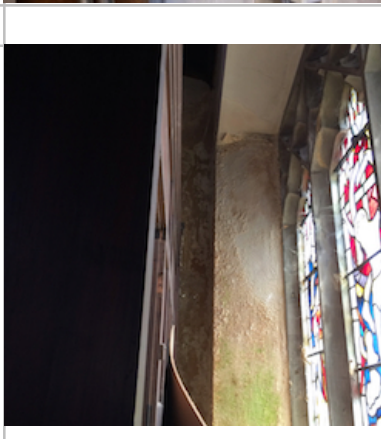
11.3	<p>The walls behind the organ are inaccessible. By viewing down the side and over the top of the organ, the walls can be seen to be 'blowing' with salts migrating through the plaster. This area was affected by a defective buttress (now rebuilt) and issues with the discharge of rainwater into the gutter. Photo shows east jamb of WS2 on the south aisle. <i>Access to be made available to be able to check the woodwork behind now that the walls are drying out and assess what to do with the decorative state of the walls (and the windows - see window section)</i></p>

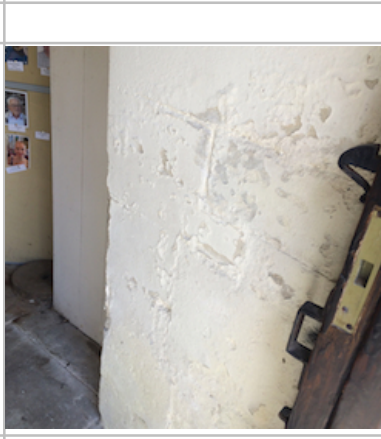
11.4	<p>There areas of blowing skim plaster/paint at low level in the tower. This is almost inevitable given the juxtaposition of absorbent, very thick walls by impervious surfaces all facing prevailing winds. <i>Loose material to be brushed off between painting cycles.</i></p>

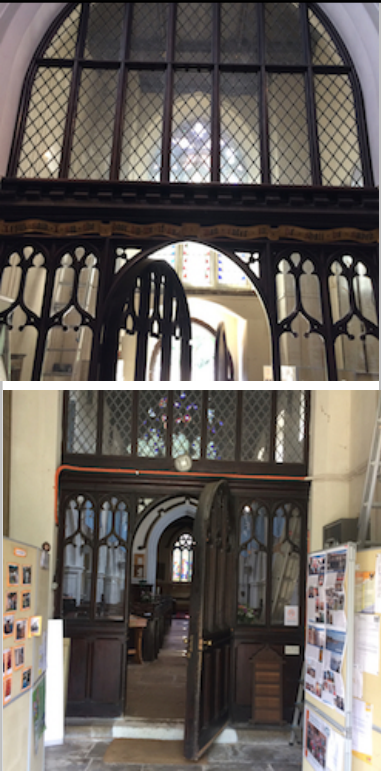
12.1	<p>The tower screen traceried , dark varnished sw with plain glazing and diamond- leaded glazing above the door. Decorative text from scripture. Satisfactory - though some joinery detail has been lost on the right hand west side and a missing bead. <i>Repair joinery</i>. Glazing is not safety glazing but the glazing is not at low level. <i>Church to be aware and review</i> .</p>

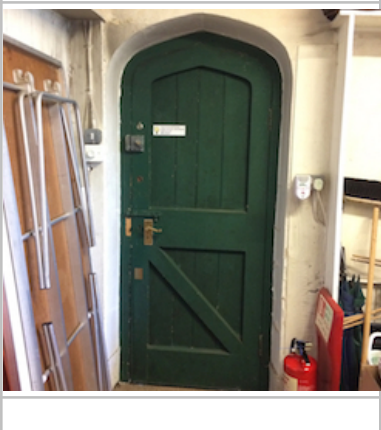
<p><b>Doors</b></p>		
12.2	<p>DN1: The flat-arched external door to the kitchen. Braced horizontal rail framing with painted softwood external bead&amp; butt t&amp;g cladding. Latch and lock, bolt and a Yale 5-lever lock. Timber surround frame. Satisfactory but <i>needs decoration where lock has been altered</i>.</p>

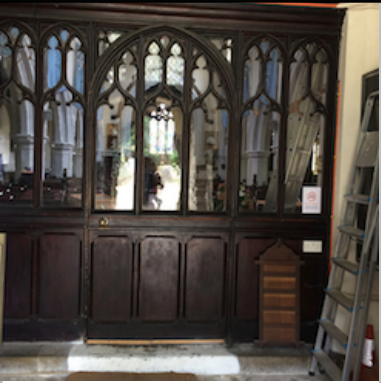
12.9	Door DW2: A wide glazed door within and matching the tower screen. Missing a horizontal beading on the west face to the mid rail. Unstained timber piece added to the bottom. Knob. <i>Piece in missing timber (needs careful joinery work) and stain new insert.</i>

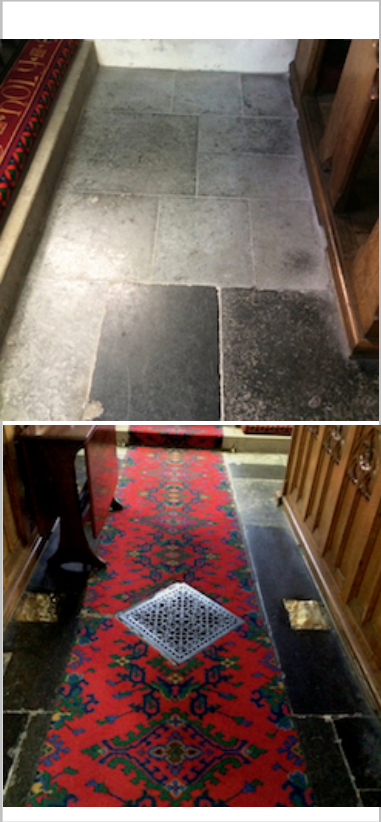
13.3	<p><b>Chancel:</b> mix of Purbeck stones (some darker) ledgers and brasses partly obscured by softwood choir platforms. Carpet strip cut around underfloor warm air heating outlet. Choir platforms compromise brass memorials in floor. See photo below.</p>
