Inspection of Churches Measure 1955 & Care of Churches Ecclesiastical Jurisdiction Measure 1991		
<b>DIOCESE OF ST ALBANS</b>		
DIOCESAN SCHEME FOR THE INSPECTION OF CHURCHES (The Quinquennial Inspection)		
<b>Church of St. Lawrence</b>

Location of the church:	Church Street Bovingdon SG13 8AY	
Local Authority:	Dacorum	
Listing: Church	Grade II*	
Inspecting Architect:	Francesca Weal MA DipArch (Cantab) RIBA SCA	
Address:	2 Mill Walk, Wheathamstead, Herts AL4 8DT	
Contacts:	01582 832907 : francesca@weal-architects.co.uk	
Dates of inspections:	10th July 2018	
Weather:	Sunny and warm	
Date of this report	5th September 2018

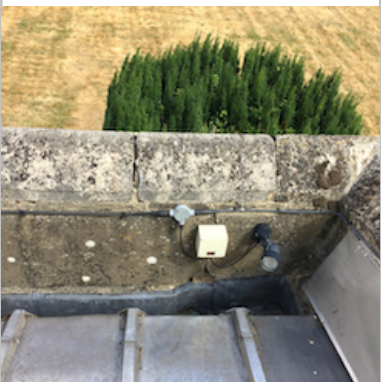
2
4.1.11	Cement render to inside of north aisle parapet is cracked in several places (see above photo) and pointing has failed in some areas above the flashings. <i>Investigate for possible rerendering in areas.</i>

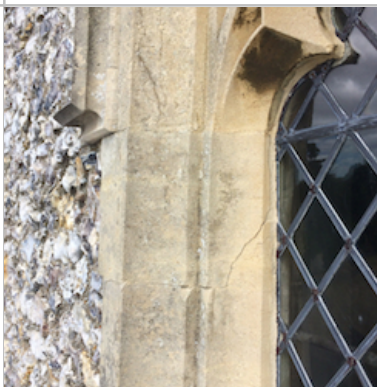
4.3.3	Crack through stone surround to WUS3. <i>Repair.</i>

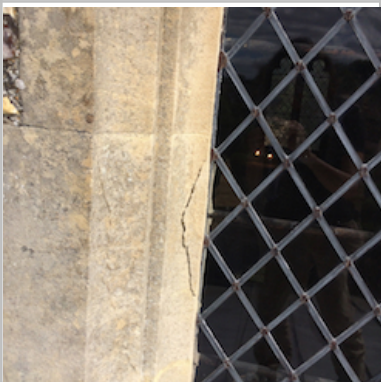
2
4.3.5	Cracks developing in WUS5 and also damaged moulding to hood mould over. <i>Repair.</i>

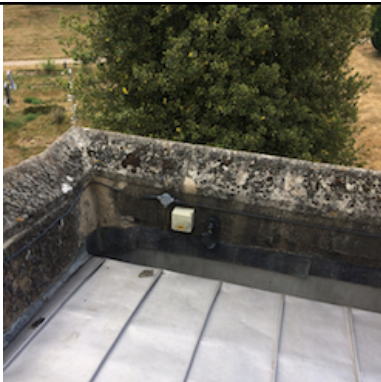
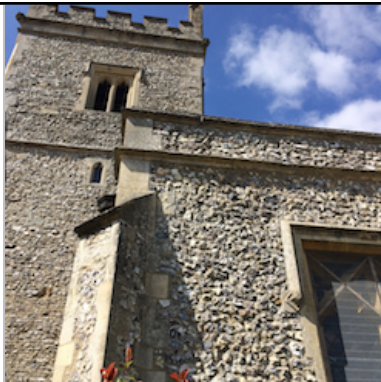
2
4.3.7	Some loss of face from the chalkstone link stones where the porch meets the wall of the south aisle. <i>Repair.</i>			3
4.3.8	Generally the south elevation of the south aisle appears satisfactory. There is some loss of materiel to the quoins to the buttresses but not enough to cause any major concern. However, if there is a programme of stone repairs elsewhere, <i>it would be wise to include some consolidation of the chalkstone where needed.</i>

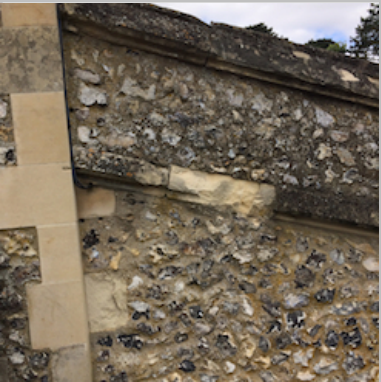
2
4.4.6	There is significant loss of face and potential loss of face to the quoins of the WC exacerbated by the use of hard cement mortar adjacent.

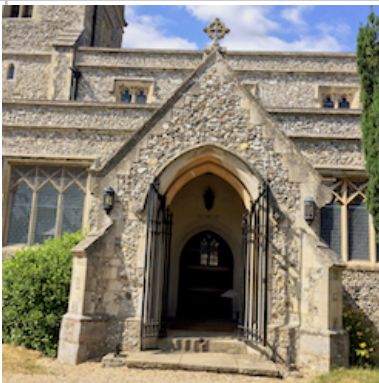
4.5.1	Generally satisfactory but some loss of face off chalkstone link stones. These <i>could be included in a programme of consolidation</i> - but otherwise not urgent.		4

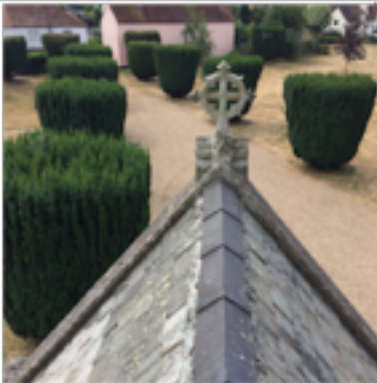
4.5.2	Possible weathering to the cross on the south face as seen from the side aisle. <i>Investigate.</i>

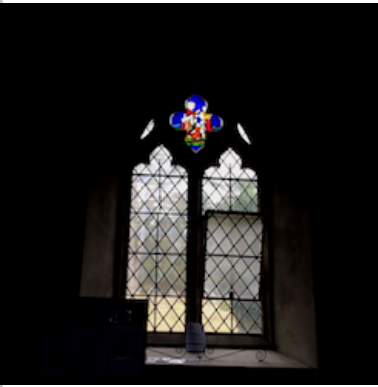
5.4	WN4: north aisle. Clear diamond quarries. Satisfactory.		
5.5	WN5: north aisle. 1877 2-light window showing 'the raising of Lazarus'. Heaton Butler & Bayne 1877. Dedicated to the architect Thomas Talbot Bury. Window is likely to need releading and a lot of the detail is fading. Galvanised guards. <i>To be investigated by specialist.</i>

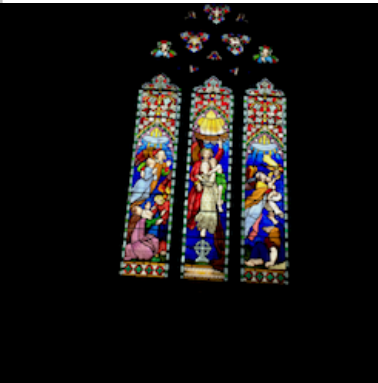
5.9	WE2: east end of chancel. 3- light window of 'Judgment Day'. W.C Cope of Lavers 1857. From ground level it looks as if a pane is coming away in the edge of blue area in the lower third of the right hand (as looking from the inside) pane. Inkwork is fading in places. Has been assessed recently by a specialist. Galvanised guards rusting. <i>PCC to assess priorities for repairing the window and attend to rusting guards.</i>

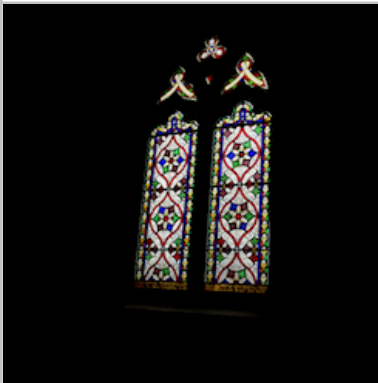
5.11	WS1: chancel, south elevation. 2-light stained glass, 1857. Previous QIR mentioned slight bulging - from below this was not obvious. Galvanised guards rusting. <i>Attend to rusting guards.</i>

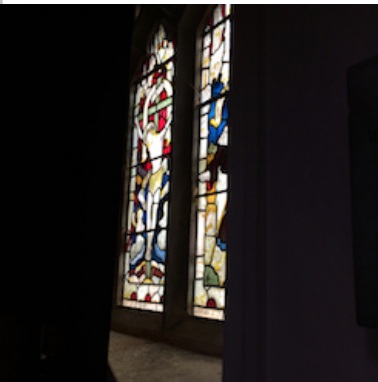
5.12	WS2 : east end of south aisle. 3-light window. Crucifixion scene. Clayton & Bell 1874. Painted glass face is very faded. Proper access to inspect potential bulging etc. impeded by organ. Has been recently assessed by a specialist. Some sign of rusting of galvanised guards. This window has been described as being in poor condition and needing attention. <i>The rusting of the guards also needs attention.</i>

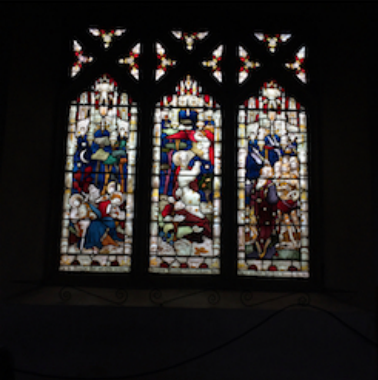
5.13	WS3: south aisle. 3-light stained glass window. Clayton & Bell 1874. Some lights fading. Galvanised guards rusting. <i>Attend to guards.</i>

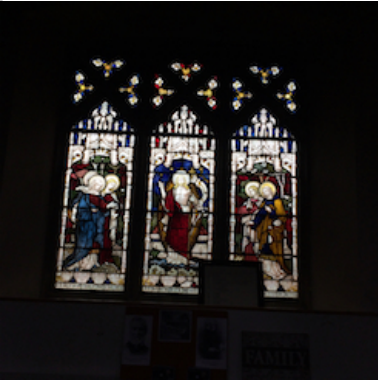
5.14	WS4: south aisle. 3-light stained glass window. 'The Risen Christ at the tomb'. Clayton & Bell 1884. Slight bulging of the leading but appears generally satisfactory. Noticed stains perhaps indicating water coming in at low level at the junction with the cill. <i>Investigate cause of ingress of water.</i>

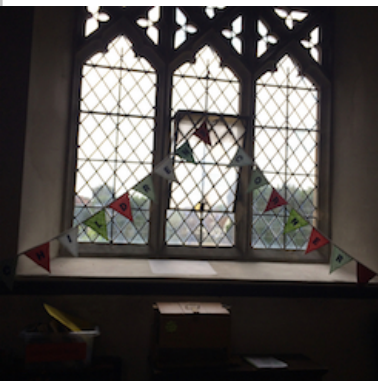
5.15	WS5: south aisle. 3-light window with centre vent by children's area. Vertical centre bar to the centre light goes through the glazing of the centre vent. Previous QIR writes that the fixed parts were releaded in 2003 though the vent leading is older. Has been recently assessed by a specialist who reported that the releading was weak and also quoted for swapping it with WS3 as instructed. Galvanised guards satisfactory. <i>Investigate why the window needs work when it was done not long ago according to the last QIR.</i>

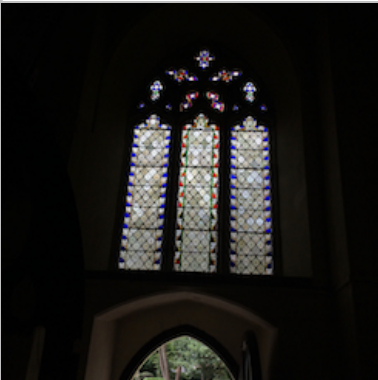
5.16	WW1: north aisle. 2-light window . Satisfactory		
5.17	WW2: 3-light window above west door. Grisaille-patterned with decorative borders. Quarries painted to resemble double-leading. Previous report referred to 7 smashed quarries - not evident at this inspection - I understand that it was repaired in the last Quinquennium. Cupric staining from fixing of guards. <i>Investigate non-staining fixings.</i>

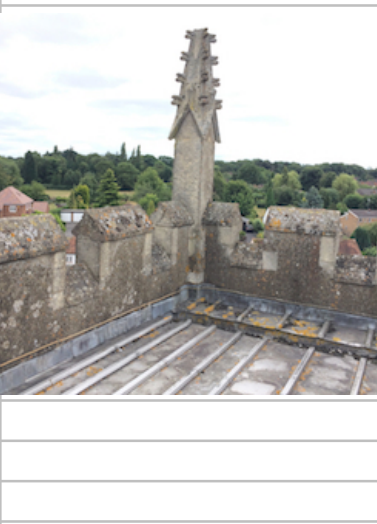
<p>Roof structure is modern, with ceiling joists onto a wallplate with sw boards and appears in good condition. New lift-off pine hatch clad in stainless steel over.</p>		
	<p>Roof covering: virtually flat, capped, stainless-steel roof set to fall to an off-centre east-west gutter. Lead flashings are unclipped which can cause them to raise- which they have done in the past. There is moss in the gutter. This should be removed regularly and flashings checked &amp; dressed down as necessary.</p>

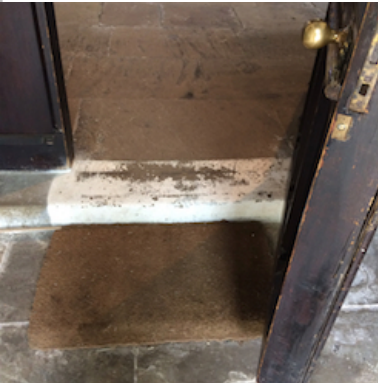
6.2.2	<b>Tower: ground level</b>		
	Fairly level threshold in from the west door. Divided from the nave by a timber screen (see later comments). Flagged floor with a step up to the nave Plastered walls. Corner boxes for the redundant clock weights(according to last QIR) in the west corners. No apparent structural defect but decorations need attention. The ceiling to the clock chamber over appears satisfactory and there are hatches for lowering the bells and a rather unsatisfactory access hatch at the top of the ladder. More comments later in QIR.

<i>Renew contrast strip to step</i>		2
	<i>Tower walls to be redecorated following works to the ladder.</i>		3

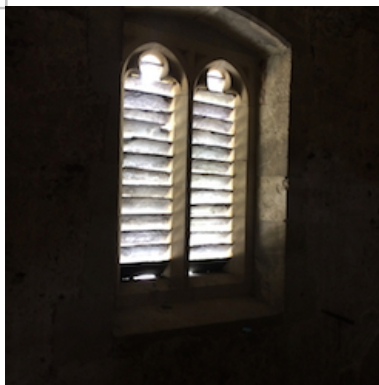
6.2.4	<b>Tower: bell chamber</b>		
	Floor is partially boarded with oak boards. Lime plastered walls but has eroded in areas exposing mixed masonry: stone, brick, flint. Four belfry openings with stone baffles in reasonable condition. Ideally the eroded lime should be repaired but at present it is not an urgent issue.

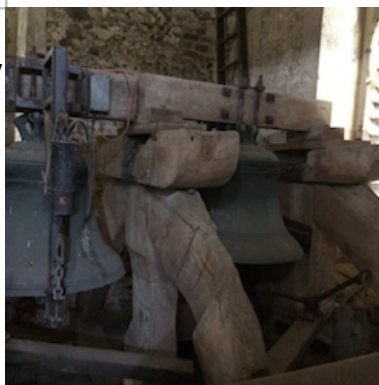
7.1	Old cruck-like bell-frame (rather special) built originally for swing chiming and certainly pre-dates the Talbot-Bury rebuild. Appears generally in good order despite the odd beetle hole.

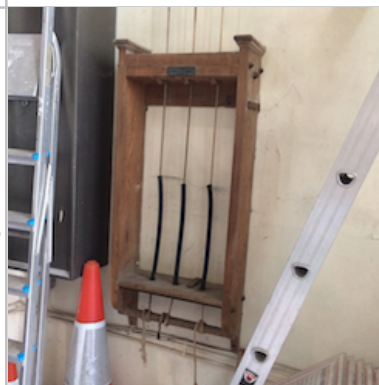
7.2	Bells have been converted to static-mounting and are now rung from an Ellicombe frame in the tower base. The previous QIR reports that they 'retain their canons and now have enlarged wooded headstock beams which are fixed over the top of the frame stalls. The three bells are dated 1663 by Chandler, 1654 by Whitmore and 1845 by Mears.'

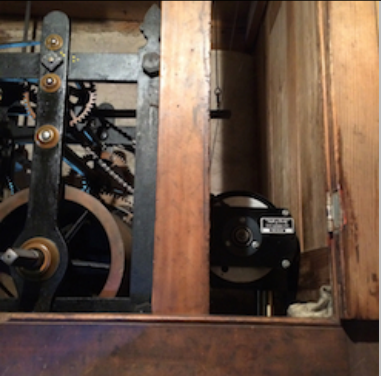
7.3	<p>Clock is mounted on the west bell-chamber opening but the mechanism is at the lower level. Ball pendulum and enclosed mechanism. 1863, Thwaites &amp; Reed. Was working during the inspection. Electric motor-driven winding and chiming. Clock face has been re-conditioned.</p>

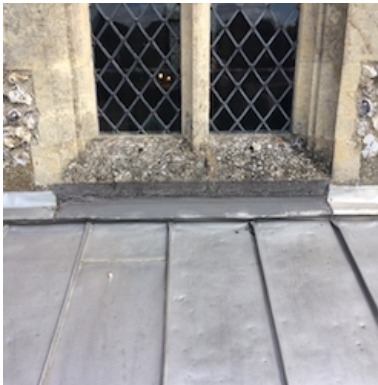
<b>8.5</b>	<b>South Aisle Roof</b>		
8.5.1	<p>External: Mono pitched roof with raised seam stainless steel sheeting. Have been advised that this dates from 1981. Pitches towards south parapet gutter with lead cover flashings.</p> <p>No apparent defect in covering but clearly there has been an issue at the junction of the upstand and the cill of one of the clerestory windows. The seal between the two appears cracked and overcoated. <i>Repair seal.</i></p>

8.5.2	<i>Check and fix back lead flashings to parapet after other works.</i>		2
8.5.3	<p>Internal: Exposed stained chamfer-stopped sw rafters with stained sw boarding over. No apparent defect.</p>

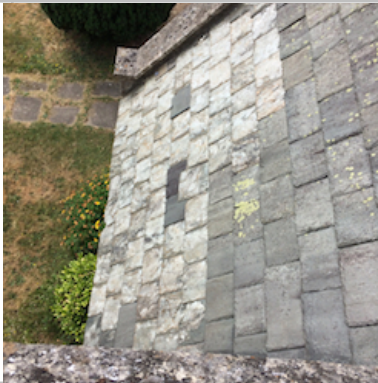
8.6.1	<p>Duo-pitched roof with a mix of slates. Some slates have been fixed back with tingles but there other slipped slates. Was advised that the porch roof was reslated in 1988. <i>Refix slipped slates.</i></p>

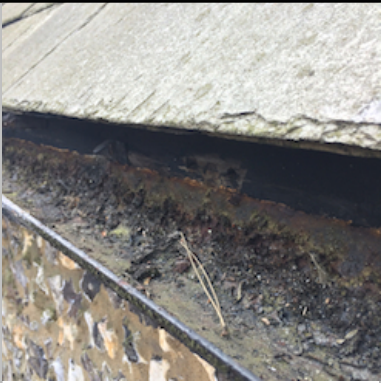
10.2	The cast iron gutter to the north side of the chancel needs attention. <i>Consideration to be given to reviewing the chancel gutters and discharge arrangements given threat of increased rainfall.</i>

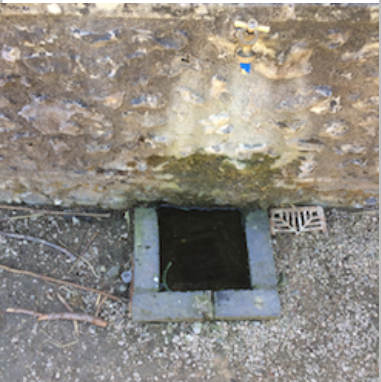
2
10.3	Sapling growing by the gully next the south chancel door. Remove. (not illustrated). Gully full of water by WC. This is still full during a dry period.

1
10.4	All gullies should be cleared. Existing system of surface water drainage also to be checked to see if blocked or the soakaways have silted up.		5
11.0	<b>INTERNAL WALLS, PLASTER, PANELLING, AND DECORATIVE STATE</b>		
11.1	There are no apparent structural cracks. But there are significant issues otherwise.

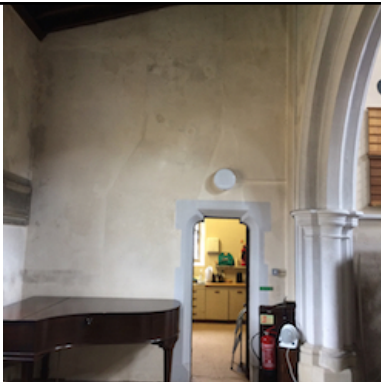
11.5	The east gable wall to the north aisle shows the ghost outline of what must have been a flue. Difference in construction or texture of construction would affect the deposit of dirt on the walls over the years highlighting the former location of the removed feature. <i>All walls need decorating.</i>

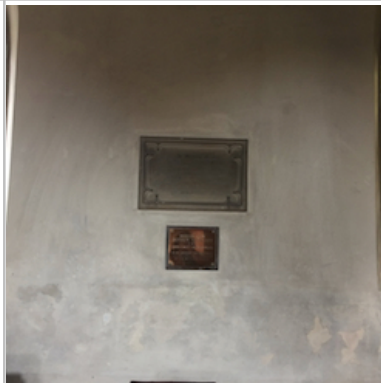
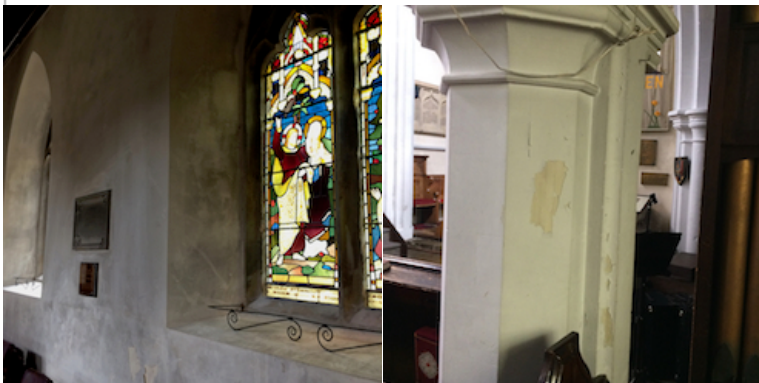
11.6	The walls are grubby, particularly on the north aisle and paint is flaking off in many areas including the arcade arches. The north aisle walls apparently were limewashed. The history behind the redecoration is uncertain. The previous QIR reported that the limewash is peeling because it was applied to an impervious paint. This is likely to be the case. <i>Decorate.</i>

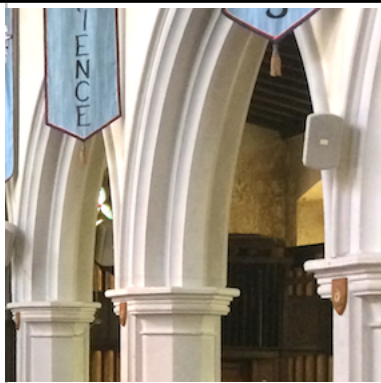
11.9	The east end of the south aisle wall is in a very unsatisfactory state and can be glimpsed from the nave over the top of the organ case. <i>Access and redecorate.</i>

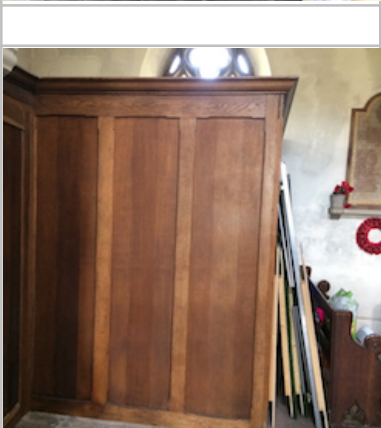
3 & 5
	<p>Screen to new vestry in west end of north aisle: modern, panelled oak screen with chamfer-stopped panel framing; in good condition</p>

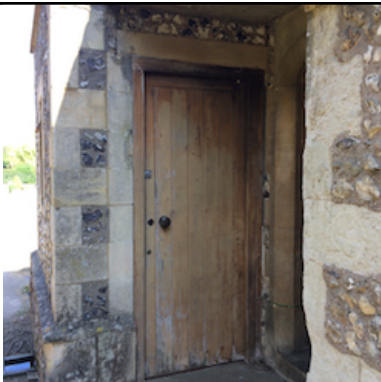
12.3	Door DE1: The external door to the w.c. Painted softwood t&g boarding. Yale lock, fixed knob handle and vacancy sign . The surrounding wood frame needs minor repairs and is slightly loose. Poor decorative state externally. <i>Repair and Decorate.</i>

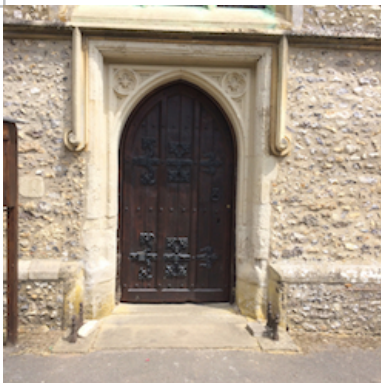
12.8	Door DW1: The tower west door, of softwood. Framed boards externally, fixed to an internal horizontal rail frame. Recently redecorated externally. There are large decorative hinges and studs. It has a wood-encased lock, another lever lock, a separate latch, a bolt and an external ring handle.

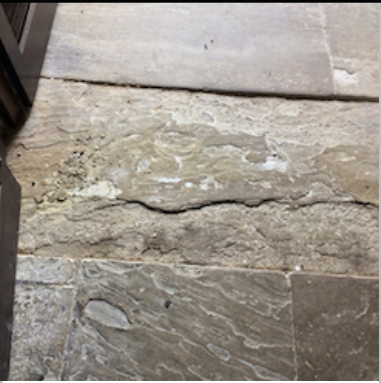
13.5	<b>Nave and south aisle floors.</b> 19C pine boards under pew positions flush to adjacent yorkstone flag alleys. One area damaged. Some alleys have been sealed with a gloss seal. Previous QIR warned against carpetting over due to risk of delamination. Noticed an area of delamination at the east end of the north aisle arcade A section of the subfloor was examined last year and the structure was found to be 19C timber joists on 19C sleeper walls. <i>Damaged floorboard in pew platform on eastern end of north side of aisle to be repaired.</i>

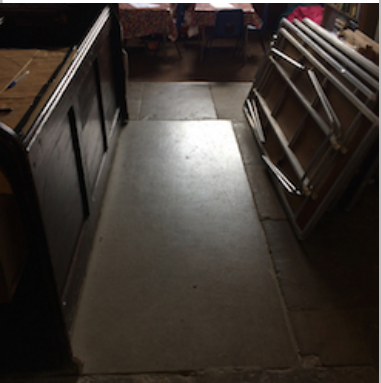
13.6	Nave floor has been infilled with ply where some pews at the rear had been removed. Not attractive but not failing. <i>Consider more worthy infill.</i>

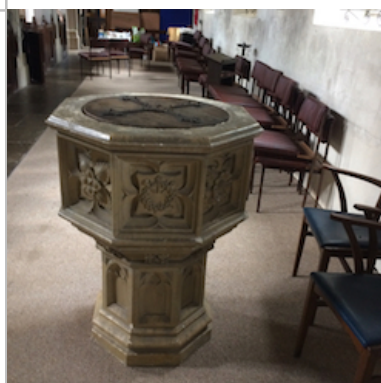
14.1.8	Font: Victorian octagonal stone font with carved panels on a sturdy octagonal base column. Wood cover. Brass collar mentioned in the last QIR appears to be sitting on the ground. Satisfactory. <i>Find a suitable place for the collar (if used in the font) so it does not go missing.</i>

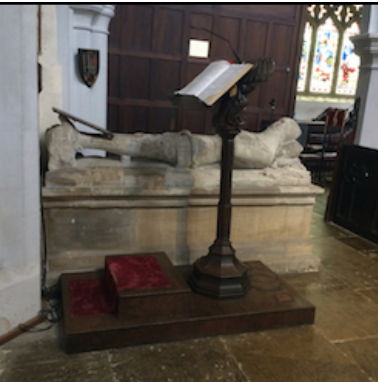
14.1.9	Eagle Lectern: 20C carved wood eagle lectern mounted on a timber platform with an additional riser on the platform. Satisfactory but not very safe for some users and with no lighting. <i>Access for less able to read at the Eagle Lectern to be reviewed. Some beetle attack to the platform by the chancel arch end. Repair.</i>

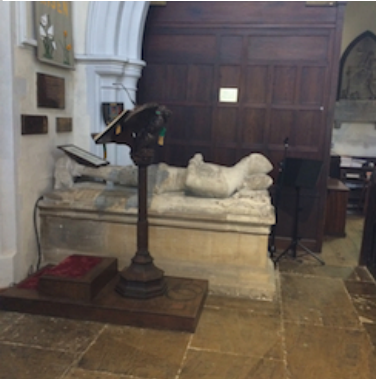
15.1	A chest tomb of a recumbent knight is placed to the north side of the south aisle at the east end of the nave. This has been moved from other, earlier locations in the course of the church's history before and after the rebuild. Some older parishioners recall it being in the west tower and a pre-rebuild engraving locates it in the one of the arcades of the south aisle - but not in the current location. It appears satisfactory.

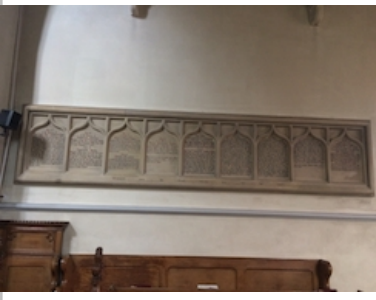
15.2	The Ryder family memorial is a set of nine continuous panels on the chancel north wall, detailing the family's local associations, including its part in the 1845 restoration of the church. Located in the chancel. It appears satisfactory. Many other memorials to Ryder family members can be found in the church.

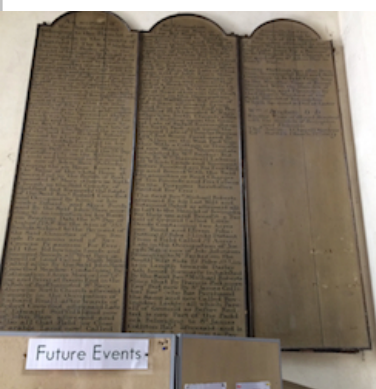
15.3	A 3 section timber tablet on the north wall of the tower lists benefactors of the parish from 1701 and culminates in an 1809 date. Not easy to access to assess condition for beetle attack etc. But otherwise appears satisfactory, if rather visually compromised by the information panel underneath.

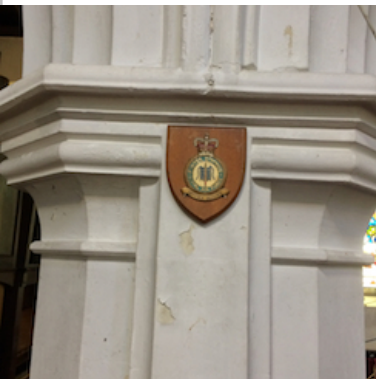
15.4	There are a series of RAF shields along the arcades intersections. One intersection (over the sound desk) does not have a shield. Otherwise satisfactory.

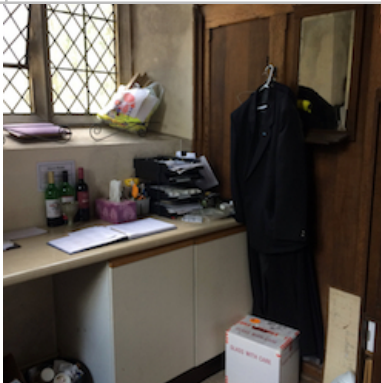
16.0	<b>VESTRY</b>		
16.1	The vestry is at the west end of the north aisle and houses the safe and vestments. The condition of the walls and floor is similar to the rest of the north aisle . The vestment cupboard matches the vestry partition. Other storage is provided by kitchen units and worktops which may not be adequate. There is no adjacent handwash facility.

16.2	<i>Storage &amp; facilities in this area could do with a review as part of other plans for the church.</i>		4
17.0	<b>HEATING</b>		
17.1	Heating is warm air, distributed by ducts under the floor with and up through cast-iron vents in the alleys. It is primitive and relies on the air being warmed in a chamber (accessed by a crawl-hole) and only when it is sufficiently hot, does it rise and distribute throughout the church. The result is not satisfactory and the parish complains of the cold. In addition, the air will contain particles of dust and dirt which contributes to the shabby appearance of the church and may even be hazardous. <i>Alternative solution to this system is needed particularly as regular maintenance is not possible.</i>

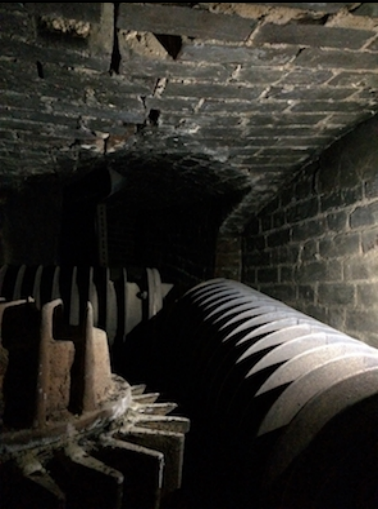
17.3	<p>The 'boiler' house is sited under the kitchen and is approached by external steps down by the kitchen's east wall. A large diameter flue rises up the north wall of the chancel . Originally solid fuel, the furnace is now an oil-fired burner . The parish has been advised that it is NOT possible to service this without dismantling it every time. There is a vented softwood door with a Yale lock. The boiler house roof is formed by a brick arch and the walls are also of bare brick. The brick arches over the castiron heat distributors did not look in good condition.<i>Brick arches to be professionally assessed and recommendations for repairs put in hand</i></p>

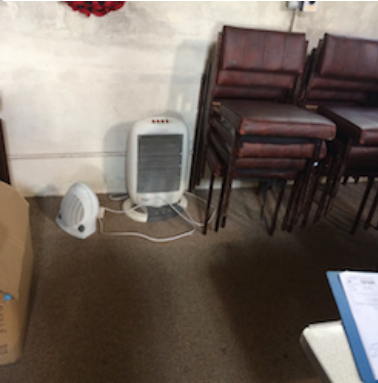
17.6	<p>I cannot comment with any figures on the safety and efficiency of this installation. Empirically, it seems very inefficient and a specialist installer should advise on safety in the absence of any regular service being possible. The inadequacy of the installation is highlighted by the evidence of a number of local electric heaters placed around the church. Which is not satisfactory for areas used by vulnerable groups. Image taken in the north aisle.</p>

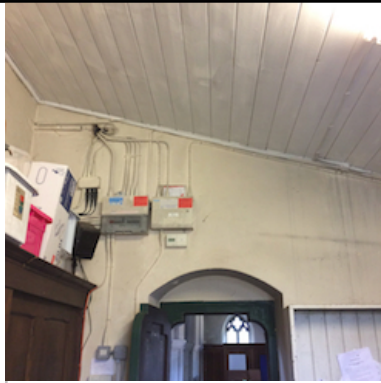
18.6	A consumer unit in the kitchen is mounted at high level and not easily accessible

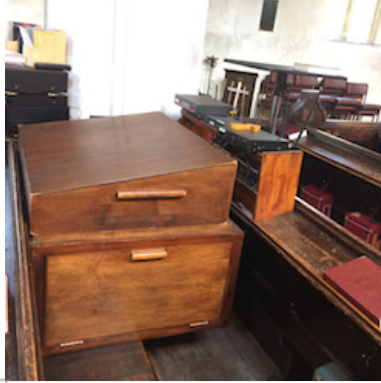
18.10	Sound system: Loudspeakers mounted above the arcade columns with larger ones towards the eastern end. The sound desk is in the middle of the north side pews to the nave. This is somewhat intrusive and looks a little precarious. When the sound system is reviewed for any upgrade, the siting and design of this should be considered.

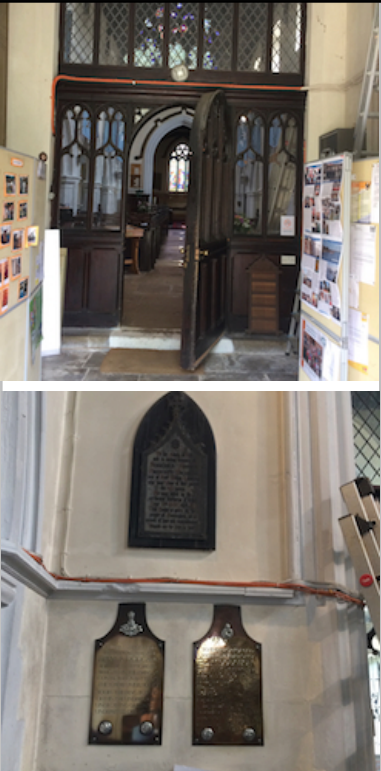
18.11	The cables generally trail in areas around the church. At the time of inspection, the cables to the small lectern by the front pew were trailing on the floor and were a trip hazard. On a subsequent visit they were tidied up and made more secure. An unsightly orange cable trails around the rear wall of the nave and across the screen at the west end and detracts from it. When future works are proposed to the system, it would be advantageous to have the cable routes and colours (or methods of concealment) etc agreed in advance of any works.

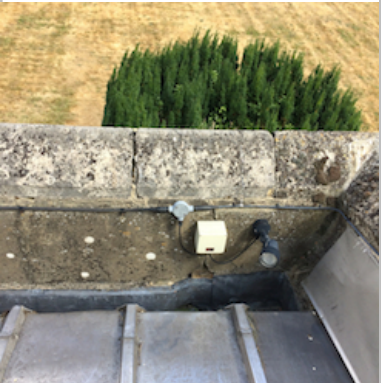
18.12	There are floodlights on the nave parapets which, according to the last QIR are there to light the tower. I did not examine these. There appear to be security lights on the north and south aisles, nave and the tower roof. Some concern expressed in the previous QIR about the fixings cracking the parapet render.

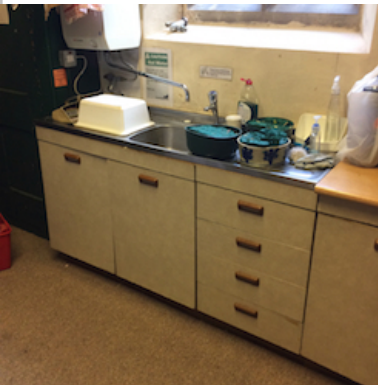
<b>21.0</b>	<b>FACILITIES etc. &amp; FOUL DRAINAGE</b>		
	<b>Kitchen</b>		
21.1	The former vestry has been converted into a kitchen with a fridge but no cooker but there are questions about its adequacy particularly for cold food preparation and assembly if that is done in this kitchen. There is no separate sink for flower arranging and cleaning and there is no separate handrinse sink apart from the WC which is outside. It is noted however, that a plastic bowl is used in addition to the sink. The units are reaching the end of their useful life. The hot water supply is defective.

21.3	It is understood that this area is awaiting longer term plans for the church. In the meantime, procedures should be reviewed to enable the best possible hygienic use of the kitchen for basic refreshments. Perhaps at least a double sink, decent, thermostatically-controlled hot water and tiling the wall behind and some temporary tall storage cupboards. This would need to be done after the works dealing with the rot.		2

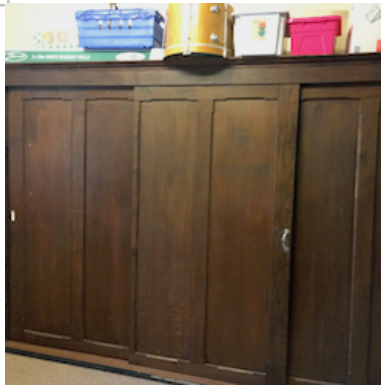
21.2	The decorative condition is very poor following damp ingress and there is rot in the timber (see earlier comments) . Cleaning & flower arranging materials, a folding table and other equipment are s stored in open view. The kitchen also contains cupboards, clearly used previously for vestments, which are satisfactory.

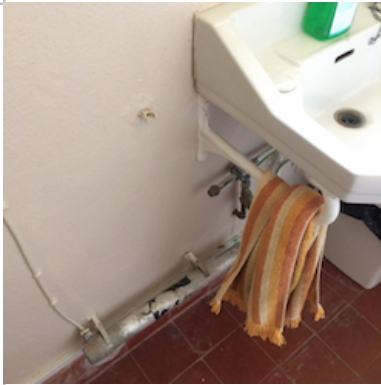
21.4	<b>WC</b>		
	The WC has a hand basin and a tubular wall heater. Previous QIR reported that the wall heater is loose and not wired in. I did not test the heater but it appeared now to be fixed and wired. It has been repainted since the last QIR though some paint on the east wall is starting to flake.

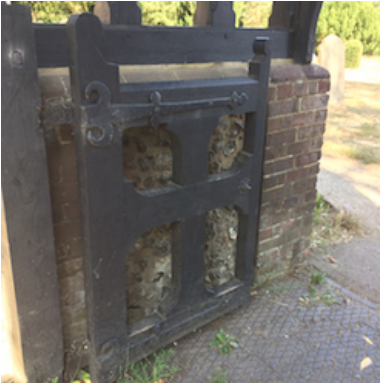
22.4	<p>At the north end of the main walkway there is a lych gate which has been substantially repaired. The structure is of an open frame of oak set on two brick side walls. The duopitched roof is tiled with machine-made tiles. The roof is supported on five trusses. The roof ridge is finished by two timber finial crosses. There are two timber gates which tend to pick up dirt from splashed water leading to algae growth. The pavings in the lych gate are diamond patterned blue engineering pavers. The dwarf wall on the west side has been partly rebuilt. The one in the image below shows the east wall.</p>

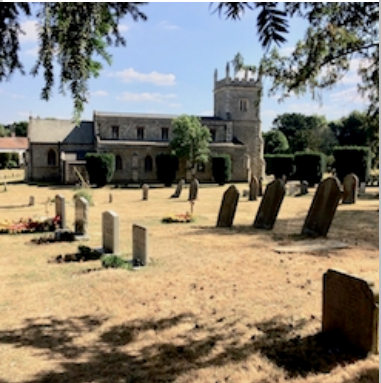
22.6	The churchyard has many headstones and table monuments. Some in a better condition than others. Some have a noticeable lean. It would be prudent to check these to see if they are loose or not. If they fall they could injure somebody. Some of the table monuments are not in good condition. Prudent to check to see if there are any risks or if some repairs need to be put in hand.

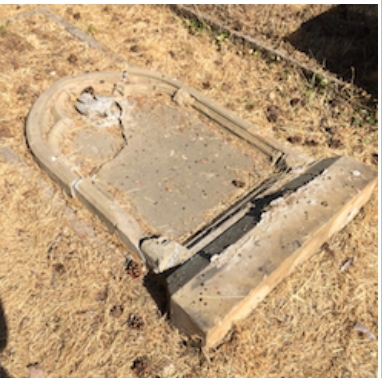
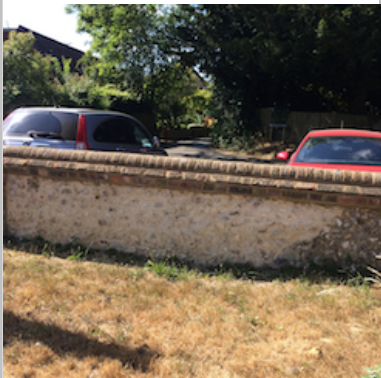
22.7	The north boundary wall has been damaged recently when a car lost control and crashed through it, damaging a tree which then damaged some headstones. The wall has been rebuilt but cement-based mortar appears to have been used for the copings which is less satisfactory.

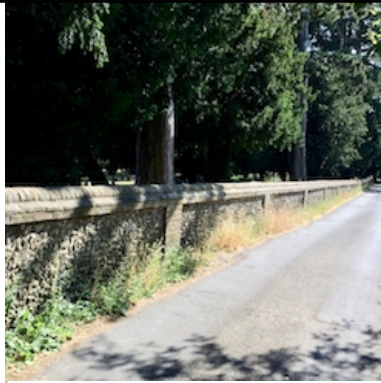
22.8	The boundary walls for much of the churchyard comprise brick piers with flint infill panels topped with bullnosed copings on plinths on headers. Generally in good condition.

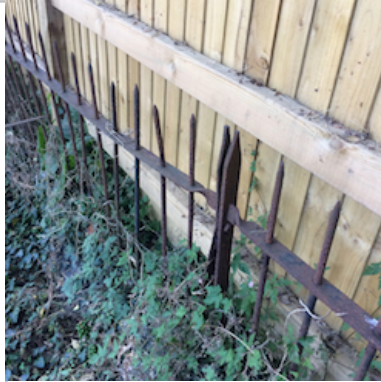
22.9	The west boundary has some remnants of old wrought-iron railings which are not in the best condition. Ideally they should be repainted but at present this is not a high priority.

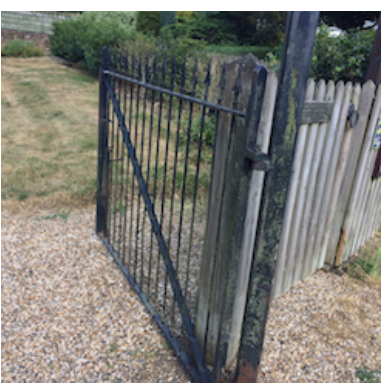
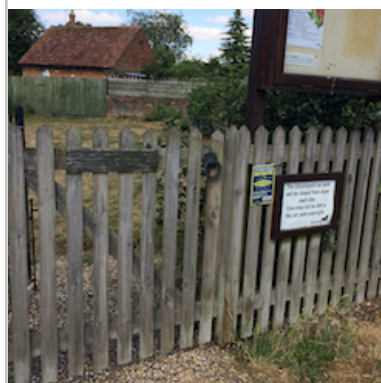
4
22.10	By the vehicular entrance on the south-west corner there is a modern iron gate for vehicles with a timber pedestrian gate and timber fence alongside. The vehicular gate needs repainting - this will not keep good condition unpainted as well as the older wrought iron fence above. The timber gate looks as if the top rail has been patch-repaired but otherwise is satisfactory.

<i>Redecorate gates.</i>		2

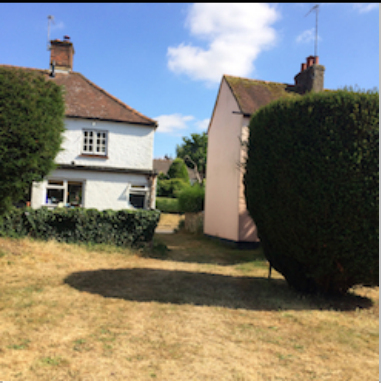
22.11	Notwithstanding all the gates, walls and fences around the churchyard, there is a wide, unguarded or gated gap giving access into the churchyard between houses on the north side of Church Road. Does this matter? Is there an historic reason for this?
